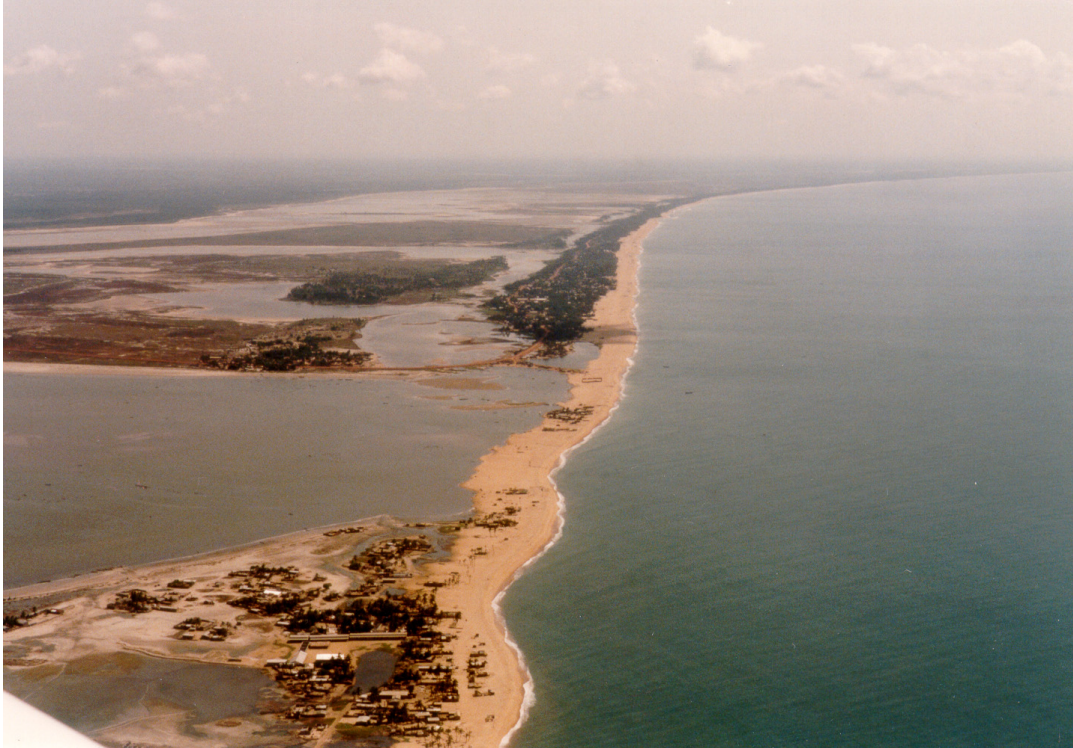
Figure III-5-6. Permanent undulations in the Keta shoreline in Ghana, West Africa, July 1996

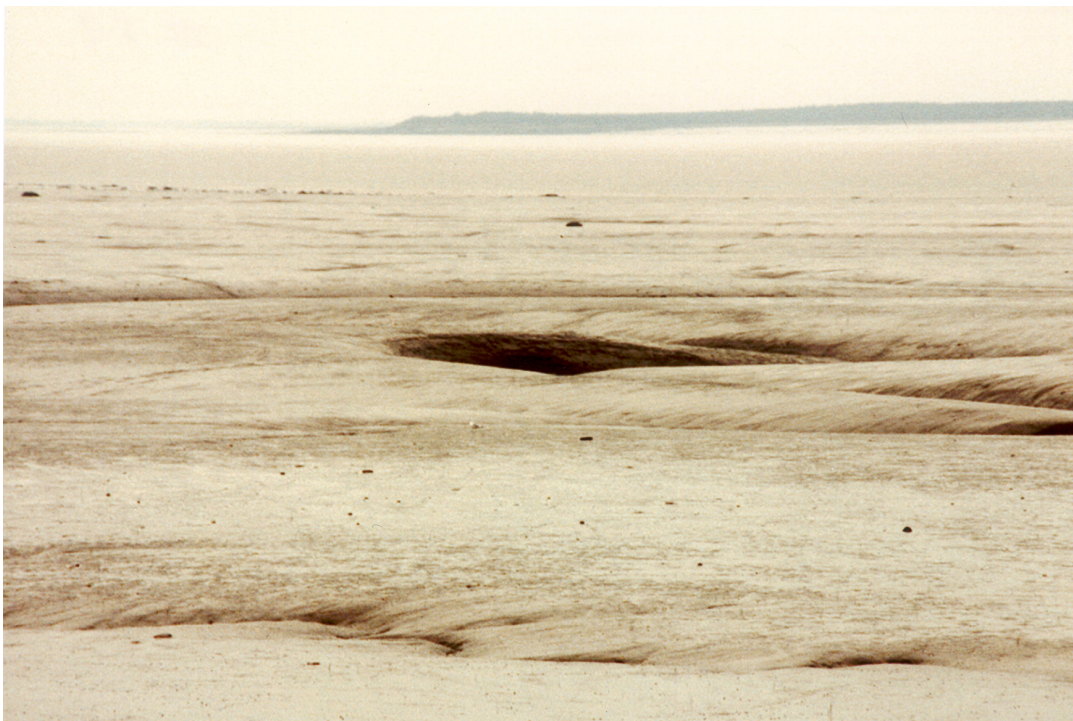
Figure III-5-7. Mud flat in Cumberland Basin, Bay of Fundy, Canada, showing drainage gullies
